Kit and caboodle

PII's entire range of inspection and integrity capabilities has helped protect a key North American pipeline network for over 20 years.

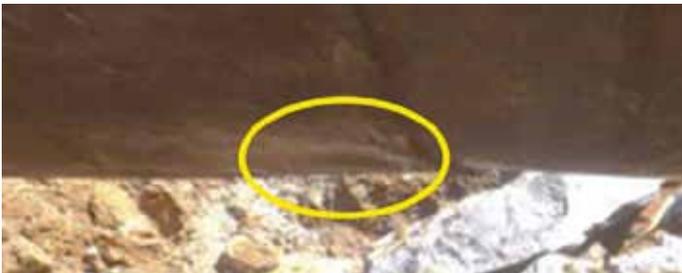
Because its slope is relatively sharp over a small area, this shallow dent has a higher strain than a deeper dent from the same inspection.

Let's consider two separate dents we detected and analyzed in the same 20" OD pipeline: one 6% OD (1.2") depth and the other 4.3% OD (0.87") depth. Although the shallower dent doesn't exceed the dent depth limit (of 6% OD), it does exceed 6% strain. On the other hand, the deeper dent is more gradual and covers a larger area, so it in fact has a lower and acceptable strain %.

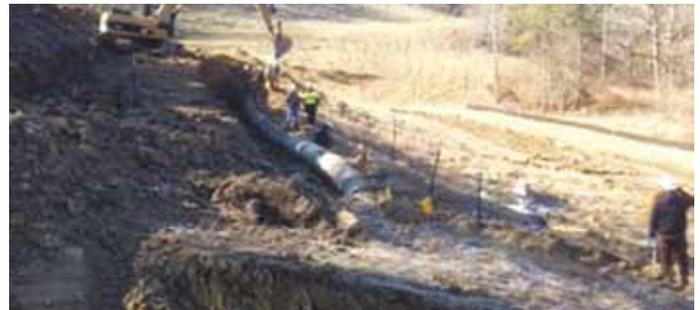
Our IMU data analysis identified a pipe that had been displaced 10 ft. downhill, with a bending strain >1%. Failure was avoided.

Running an IMU has since become routine practice for the client. In the last two years, we've used our IMU data for strain screening and full bending strain assessments on 45 of its pipelines. A screening assessment gives a rapid summary of the top five strain events in the pipeline, which is sufficient to determine if a full bending strain assessment is warranted. Indeed, a high bending strain was identified the very first time we conducted an IMU survey plus strain assessment for the client. When the client's personnel visited this site, they found that a significant land movement had shifted the pipe approximately 10 feet downhill, resulting in a strain of just over 1%. With the potential failure averted, IMU and bending strain assessments were instantly recognized as cost-effective additions to the client's integrity program.
